SEAT Leon

Sports Tourer (from 2020)

1. Identification / recognition

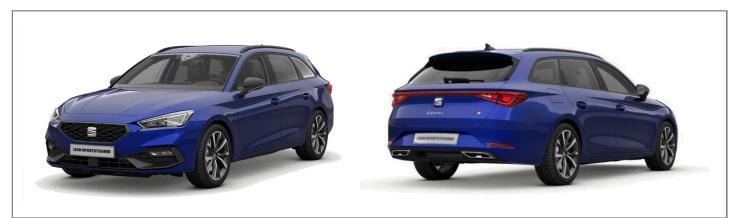
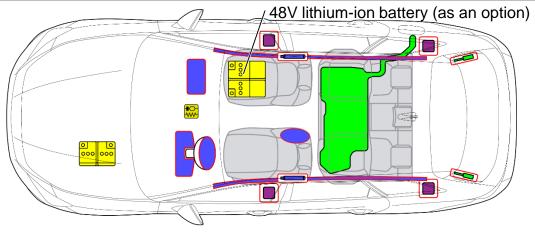
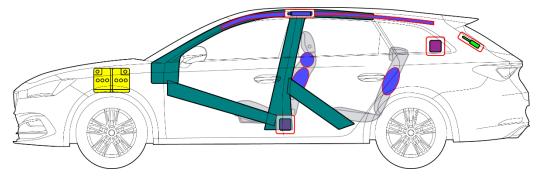
Information: the illustration shows the maximum possible range of equipment.

Airbag		Gas generator	Belt tensioner	*	SRS control unit		Active pedestrian protection system
9	Automatic rollover support system		Gas strut / pre- tensioned spring	High-strength area		Special attention		
000 000	Low-voltage battery	HH	Low-voltage ultra- condenser	Fuel tank		Gas tank		Safety valve
0 0	High-voltage battery	2	High-voltage cables	High-voltage device to the high- voltage shutdown system		Fuse box Deactivation High-voltage system	4	High-voltage super- condenser
